Quality Assurance and Source Inspection

Contract #: 04-0120F4Cty: SF/ALA Rte: 80 PM: 13.2/13.9File #: 69.28**WELDING INSPECTION REPORT****Resident Engineer:**Siegenthaler, Peter**Address:** 333 Burma Road**City:** Oakland, CA 94607**Report No:** WIR-023995**Date Inspected:** 18-May-2011**Project Name:** SAS Superstructure**OSM Arrival Time:** 700**Prime Contractor:** American Bridge/Fluor Enterprises, a JV**OSM Departure Time:** 1900**Contractor:** Zhenhua Port Machinery Company, Ltd (ZPMC), Changxing Island **Location:** Shanghai, China**CWI Name:** An Qing Xiang**CWI Present:** Yes No**Inspected CWI report:** Yes No N/A**Rod Oven in Use:** Yes No N/A**Electrode to specification:** Yes No N/A**Weld Procedures Followed:** Yes No N/A**Qualified Welders:** Yes No N/A**Verified Joint Fit-up:** Yes No N/A**Approved Drawings:** Yes No N/A**Approved WPS:** Yes No N/A**Delayed / Cancelled:** Yes No N/A**Bridge No:** 34-0006**Component:** OBG Components**Summary of Items Observed:**

Outside Yard – OBG Trial Assembly

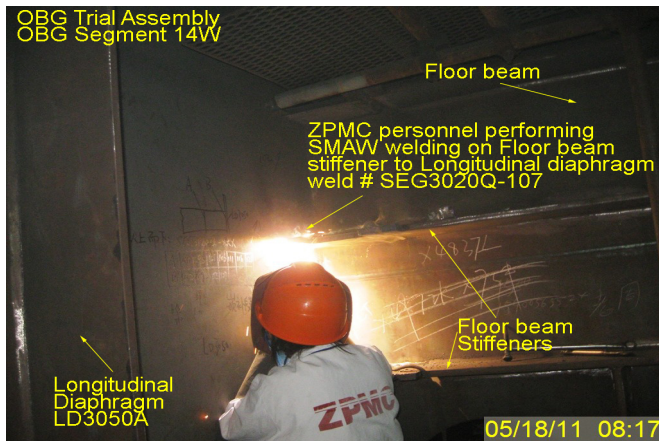
This QA Inspector observed ZPMC qualified welding personnel identified as 040655 perform welding by Shielded Metal Arc Welding (SMAW), on Floor beam stiffener to longitudinal diaphragm LD3050A weld at panel point 126 of OBG Segment 14W. Weld joint is identified as SEG3020Q-107. ZPMC Quality Control (QC) Inspector identified as Zhu Lin was present to monitor the welding process. The welding variables recorded by ZPMC QC appeared to be in general compliance with WPS-B-P-2214-Tc-U4b-FCM-1. See attached picture.
